## **TEST REPORT**

Fire-resistance test of GSM Wall Boxes  
protecting General Power Outlet  
systems and Wall switches installed  
into a 116mm thick fire rated  
plasterboard wall system tested in  
accordance with AS1530.4-2014

47083900.1

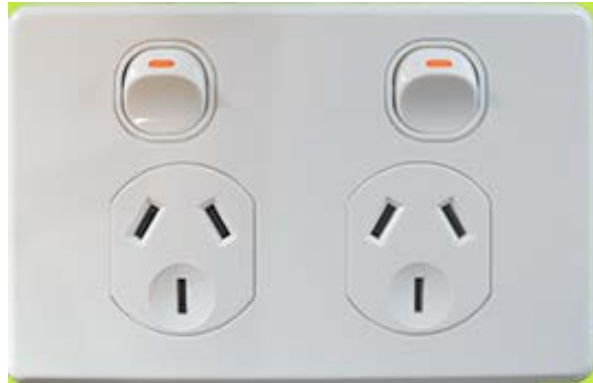
| Item | Description | |
|---|---|---|
| | Product name | PUPP2G, Trader™ Power Point Switched 2 Gang 10A 250V~<br> |
| | GPO dimensions | Overall dimensions of the GPO was 116mm wide × 75mm high × 24mm deep<br>Visible dimensions of the GPO was 116mm wide × 75mm high × 13mm deep |

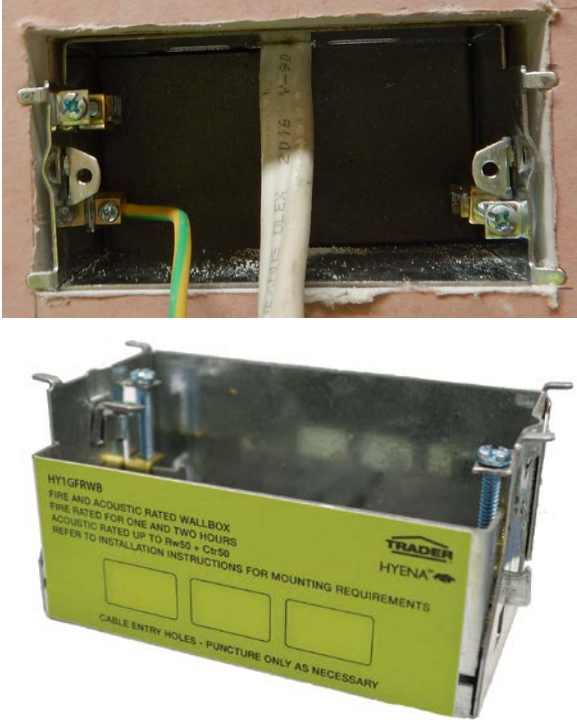
| Item | Description | |
|---|---|---|
| | GPO wall box size | <p>Overall dimension of the wall box was nominal 95mm wide × 51mm high × 50mm deep on the longer edge and 38mm deep on the shorter edge.</p> <p>The shell of the wall box was made from 0.9mm thick galvanized steel.</p> <p>There are three holes located at the top edge plate with dimension 16mm wide × 10mm high.</p> |
| | Intumescent | 2 pieces of intumescent were installed inside the wall box. The overall dimensions of the intumescent pieces were approximately 46mm wide × 48mm long × 7mm with a density of 1294kg/m <sup>3</sup> . |

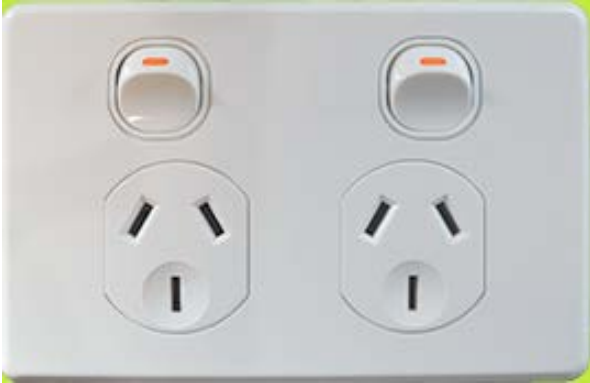
| Item | Description | |
|---|---|---|
| | Product name | PUPP2G, Trader™ Power Point Switched 2 Gang 10A 250V~<br> |
| | GPO dimensions | Overall dimensions of the GPO was 116mm wide × 75mm high × 24mm deep<br>Visible dimensions of the GPO was 116mm wide × 75mm high × 13mm deep |
| | GPO material | Polycarbonate (PC) |

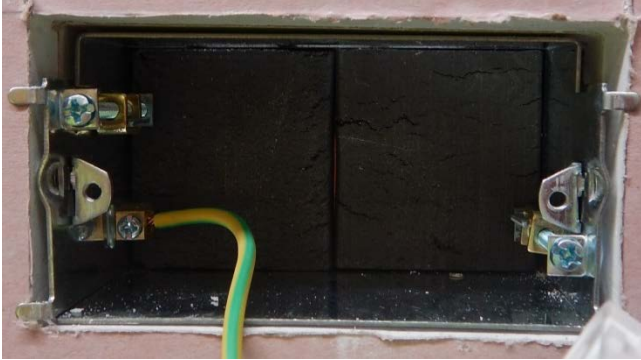
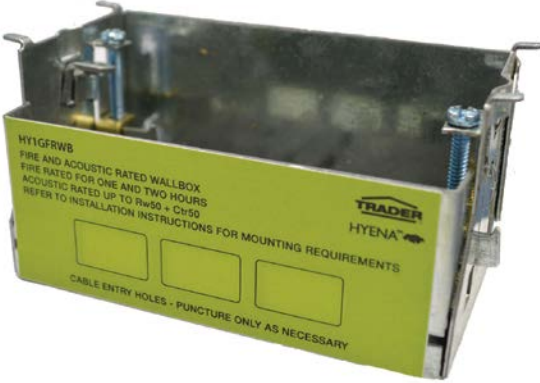
| Item | Description | |
|---|---|---|
| | Product Name | HYGFRWB Fire and Acoustic Rated Wall Box with Earth |
| | GPO wall box size | <p>Overall dimension of the wall box was nominal 95mm wide × 51mm high × 50mm deep on the longer edge and 38mm deep on the shorter edge.<br/> The shell of the wall box was made from 0.9mm thick galvanized steel.<br/> There are three holes located at the top edge plate with dimension 16mm wide × 10mm high.</p> |

| Item | Description | |
|---|---|---|
| | Location | GPOs and the wall boxes were installed on both exposed and unexposed side. There was 16mm spacing between the exposed and unexposed side wall box. Both wall boxes were located at 920mm above the sill of the specimen. The GPOs were staggered and had an east-west offset of 30mm in between each other. |

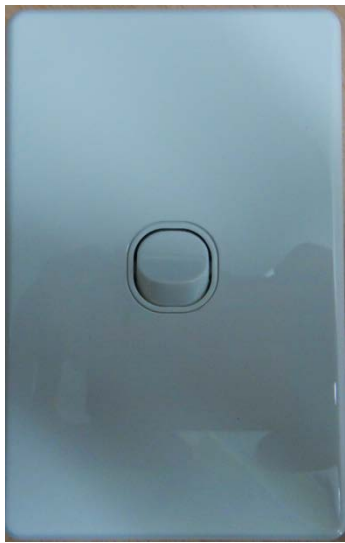
| Item | Description | |
|---|---|---|
| | Product name | PUSWV1G, Trader™ Switch Vertical 1 Gang 10AX/16A 250W~<br> |
| | Switch dimensions | Overall dimension of the switch was 117mm high × 75mm wide × 13mm deep |

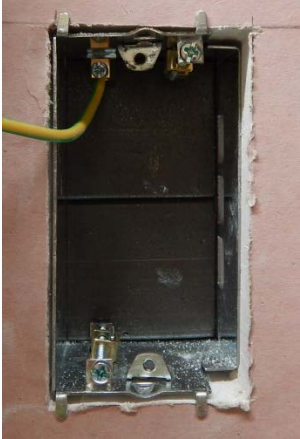
| Item | Description | |
|---|---|---|
| | Product Name | HYGFRWB Fire and Acoustic Rated Wall Box |

| Item | Description | |
|---|---|---|
| | GPO wall box size | <p>Overall dimension of the wall box was nominal 57mm wide × 95mm high × 50mm deep on the longer edge and 38mm deep on the shorter edge.</p> <p>The shell of the wall box was made from 0.9mm thick galvanized steel.</p> <p>There are three holes located at the top edge plate with dimension 8mm wide × 20mm high.</p> |
| | Location | <p>GPOs and the wall boxes were installed on both exposed and unexposed side. There was 16mm spacing between the exposed and unexposed side wall box. The unexposed wall box was located 874mm above the sill of the specimen, whilst the exposed side wall box was located 750mm above the sill of the specimen.</p> |
| | Intumescent | <p>2 pieces of intumescent were installed inside the wall box. The overall dimensions of the intumescent pieces were approximately 46mm wide × 48mm long × 7mm with a density of 1294kg/m<sup>3</sup>.</p> |

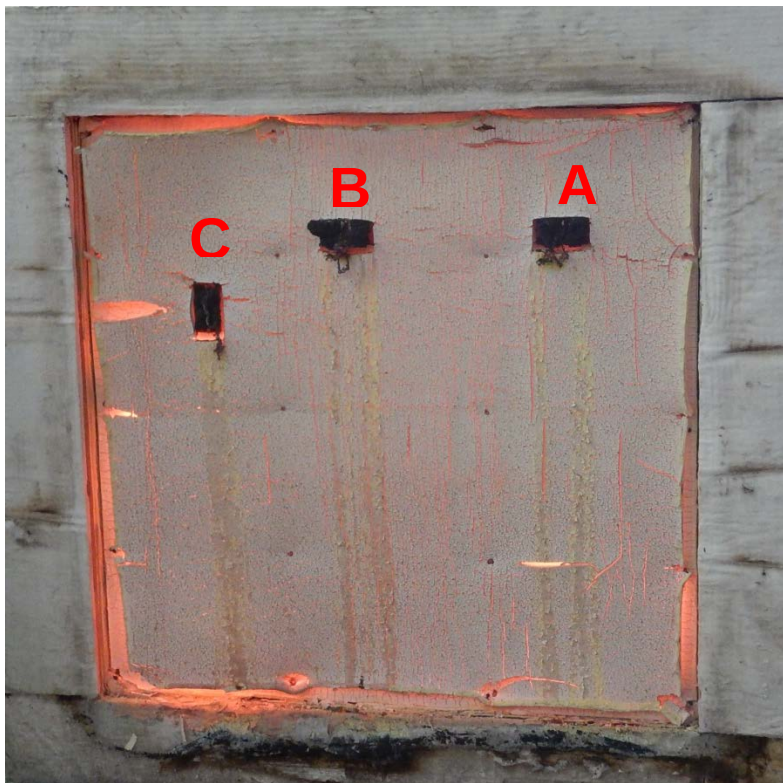
Figure A6.4. Exposed face of specimen after the end of the fire-resistance test.

| Time<br>Min Sec | | Observation |
|---|---|---|
| 25 | 33 | It had become evident that the GPO on the exposed side has melted off. |
